## Trouble Shooting Guide For HIPERTOCH® 24 Series Triggers

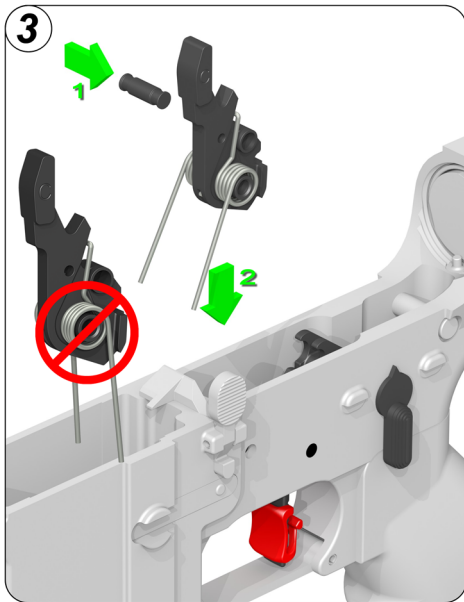
1) The hammer does not fall when the trigger is pulled when the gray (plain) toggle springs are installed; but, nudging the hammer will cause it to fall. When the Blue or Yellow toggle springs are installed, the hammer falls when the trigger is pulled, but only results in light firing pin strikes that fail to touch off the cartridge primers in some or most cases, independent of ammunition manufacturer.

*The hammer spring is installed backwards. See Figure at left showing correct and incorrect hammer spring installations.*

**REMEDY:** Install the hammer spring correctly.

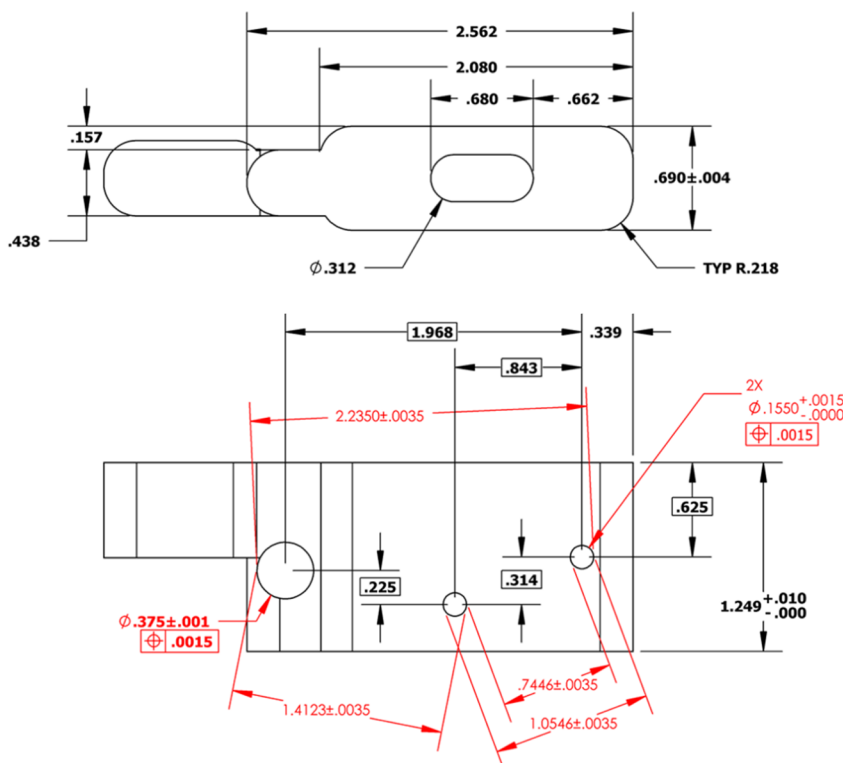
## "AR10" and "AR15" Fire-Control Cavities

1) The lower receiver pivot pin spacing is too close together, or the lower receiver's pivot pin holes are worn out (diameters too large,

or oblong) preventing disengagement of the semi-auto disconnecter's sear with the hammer's secondary sear. See the Figure at left showing the in-spec FCG fire control cavity and pivot holes spacing dimensions. 2) The pistol grip screw is too long. It prevents the trigger from rotating fully forward at the trigger bow because the rear underside hits the protruding pistol grip's attachment screw. 3) Debris is in the FCG cavity (small bits of gravel, blown primer cups, shards of cartridge brass, etc.) preventing the trigger from rotating fully forward, because of an obstruction along the trigger's rear underside.

**REMEDY:** 1) Inspect the lower for dimensional compliance and/or substitute an in-spec lower for installation. 2) Replace the over-long grip screw with a shorter one, or file the end back to eliminate the obstruction and reinstall. 3) Clean out the large scale debris in the lower's FCG cavity.

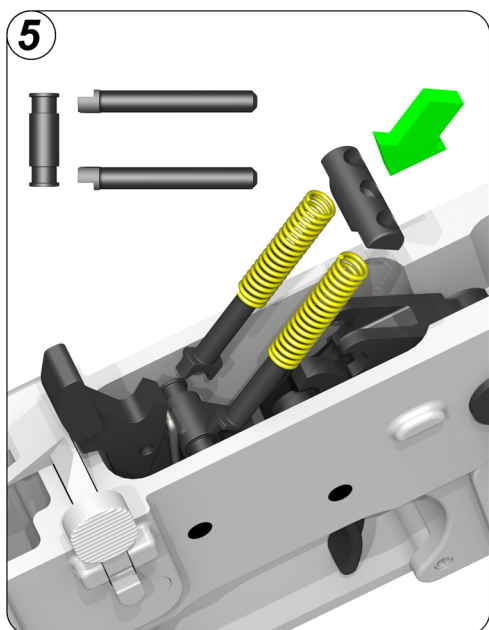
When the rifle is live-fired, the toggle shafts come off at the hammer and sometimes become lodged in the FCG bending one or both of the toggle springs, or worse.

*The toggle shafts were installed incorrectly. See the photos above and the figure to the left for correct installation. The ends of the toggle shafts that fit onto the toggle spindle (installed in the hammer) are asymmetric in shape. The side cut, or shelf, must face outboard on both. If one or both face inboard, the shafts do not seat on the spindle and may push it to one side or the other with respect to the hammer and therefore only partially engage either or both toggle shafts. When the shafts are installed correctly, they are parallel. But, they can also appear parallel when installed incorrectly, so pay attention during installation. Hammer motion during live-fire is extremely fast. Improperly seated shafts are not held firmly in place by the toggle spring’s compressive forces and they will dislodge sooner or later with unpredictable results.*

**REMEDY:** *Install the toggle shafts correctly so that they will not dislodge and the FCG will operate normally and reliably as designed.*
